## IMPACT DAMAGED PIER STRENGTHENING USING CFRP FABRIC

On October 21, 2015, a semi-trailer truck traveling south on the W.H. Natcher Parkway, near Bowling Green, Kentucky collided with the north pier supporting the Elrod road overpass. The impacted bridge is a four-span, 67 m (220 ft) long, reinforced concrete deck girder bridge. Large diagonal cracks propagated up the entire height of the column from the impact point. Horizontal cracking also appeared around the entire circumference near the point of impact. Large cracks occurred on the top face of the pier cap, between the girder pedestals, extending in the transverse direction. Because winter weather was approaching, the Kentucky Transportation Cabinet (KYTC) deemed a rapid retrofit necessary to maintain the bridge's structural integrity. Two types of uniaxial Carbon Fiber Reinforced Polymer (CFRP) fabric and one braided triaxial CFRP fabric were utilized in the retrofit design. A heavy uniaxial CFRP fabric was utilized as the primary strengthening material for the impacted column. A finite element model was utilized to analyse the effectiveness of the column retrofit. The retrofit construction work was completed in five workda

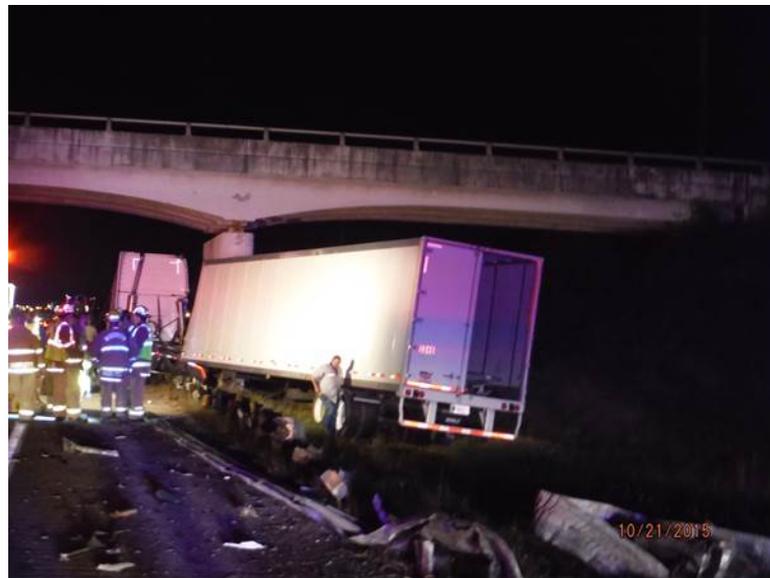
Another method of bridge pier damage is due to accidental heavy vehicle collision, sometimes leading to loss of life and complete destruction of the bridge [7]. While certain code provisions such as AASHTO [8] exist for the design and placement of bridge piers next to roadways, these typically do not address vehicle characteristics and travel speeds [7]. The present paper details bridge pier damage due to an accidental truck impact, and the subsequent retrofit design and construction using Carbon Fiber Reinforced Polymer (CFRP) fabric. On October 21, 2015, a semi-trailer truck traveling south on the W.H. Natcher Parkway, near Bowling Green, Kentucky collided with the north pier supporting the Elrod road overpass. While a guardrail existed between the roadway and the pier, the semi-trailer truck had overrun the guardrail prior to impacting the pier column as shown in Figure 1.

Figure 1: Semi-trailer truck impact on Elrod road bridge

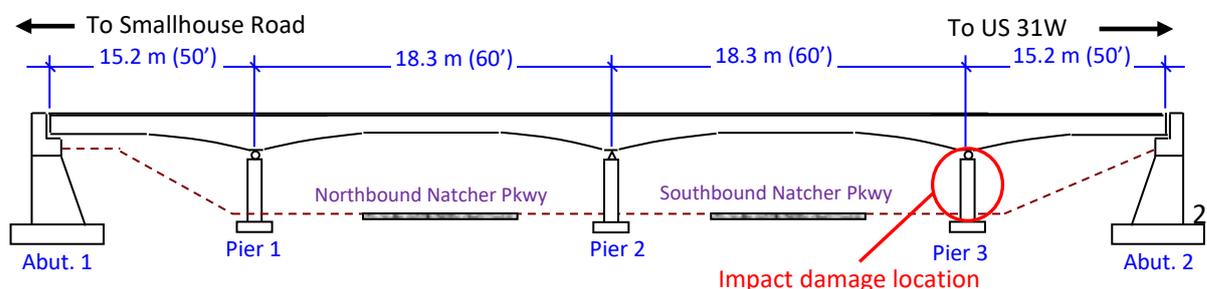
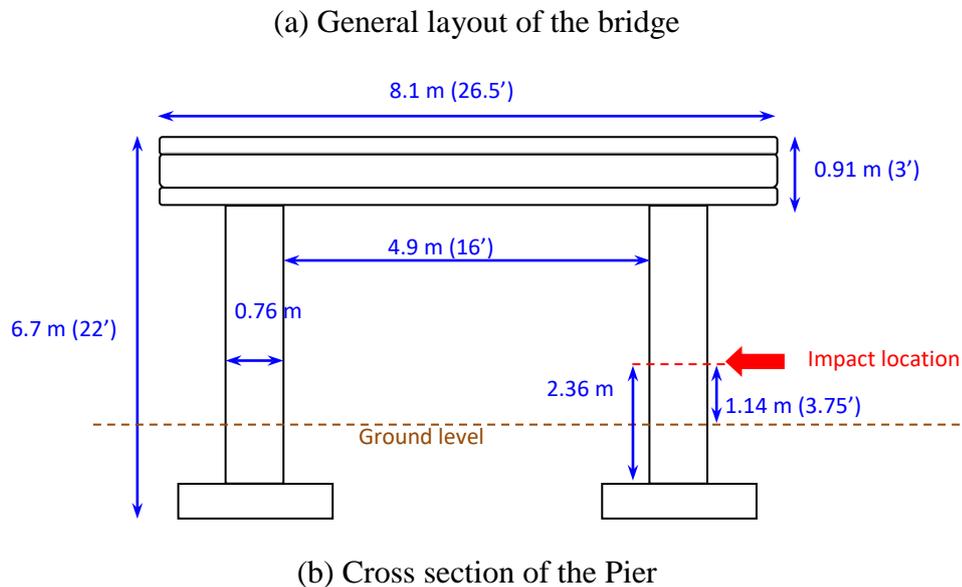
The Elrod road impacted bridge is a four-span, 67 m (220 ft) long, reinforced concrete deck girder bridge. The two center spans of the overpass are over the northbound and southbound lanes of W. H. Natcher Parkway in Kentucky. Each pier of the bridge is comprised of two reinforced concrete pier columns supporting the pier cap. The four cast-in-place reinforced concrete girders are continuous across the length of the bridge. While the girders were fixed over the center pier (pier 2), at all other locations including the impacted pier (pier 3) the girders rested on roller supports which allowed translational movement. The 0.76 m (2.5 ft) diameter RC pier column is reinforced by 8 No.32 (#10) rebars with a nominal diameter of 32.26 mm (1.27 inch). A general layout of the bridge and cross section of a pier identifying the impact area is shown in Figure 2.

Figure 2: Layout of the Elrod Road bridge with impact damage location

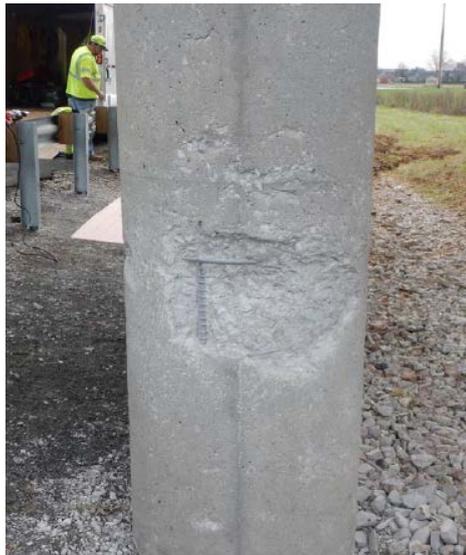
The semi-trailer truck collided with the north pier column of pier 3. Possibly due to a low impact speed and the guardrail potentially reducing the force of impact, the structural damage to the pier did not cause immediate failure of the bridge. The impact force had caused sufficient lateral movement between the pier and the beams that the rocker socket ends on each of the four RC beams were sheared. Concrete was damaged at the impact location, approximately 1.14 m (3.75 ft) above ground elevation, producing cracks on the impacted pier column as well as the pier cap above. Figure 3 highlights the damage at the impact location and the cracking in the column and pier cap.

(a) Impacted area of column

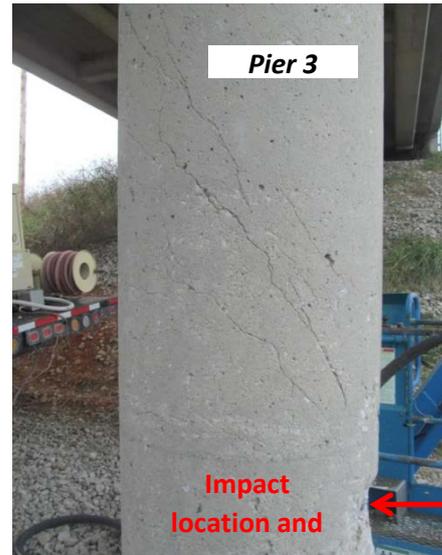
Large diagonal cracks propagated up the entire height of the column from the impact point (Figure 3(b)). Horizontal cracks appeared around the column's entire circumference near the point of impact. Diagonal cracking occurred at the top of the column, where it intersects the pier cap (Figure 3(a)). Large transverse cracks appeared on the top face of the pier cap, between the girder pedestals (Figure 3(d)). Some transverse cracks spanned the entire width of the pier cap, with others extending down along the two vertical side faces. The cracks on the impacted column and pier cap affected the structural integrity of the bridge and raised concerns over whether they would accelerate corrosion of the reinforcing steel and lead to the deterioration of concrete. The objective of the retrofit was to repair and strengthen the impacted pier column and pier cap. Due to approaching winter weather, the Kentucky Transportation Cabinet (KYTC) required that the retrofit be designed and constructed rapidly.

(b) Impacted column east face

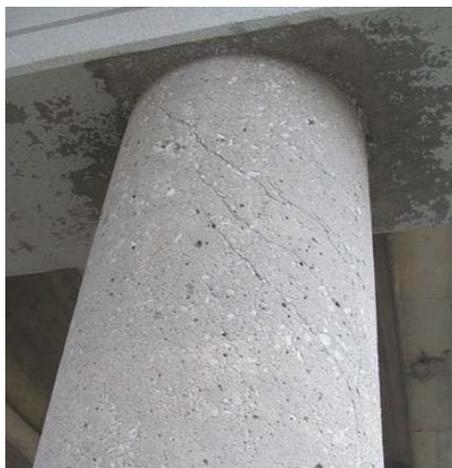
(c) Top of impacted column

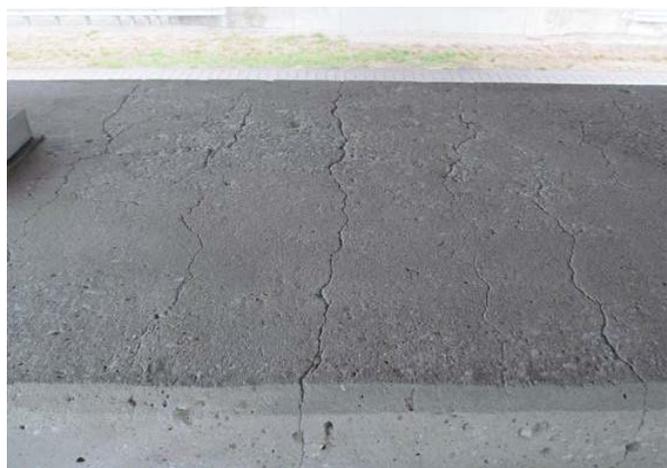
(d) Cracking on top of pier cap

The axial capacity of the impacted column was of concern due to cracking. The structural integrity of the pier cap was concerning due to the cracks on the top of the pier cap. CFRP fabric was selected as the retrofit material for the damaged pier column and pier cap due to its high strength-to-weight ratio, which makes it an ideal material for quick and efficient repairs. Along with providing strength, the repair scheme was selected to protect the steel reinforcement, as corrosive agents could potentially penetrate the widening cracks. Several different types of CFRP fabric, including two uniaxial CFRP fabrics and a braided triaxial CFRP fabric, were used for the retrofit. The fabric selected depended on the type of strengthening being carried out. Table 1 lists the physical and mechanical properties of the CFRP fabric.

All three types of CFRP fabric were utilized for the pier cap retrofit. The UCF 120 uniaxial fabric, which can carry 535 kN of tensile force per 305 mm (120 kips of per 1-ft) width of fabric, was the first CFRP fabric used. To strengthen the top of the pier cap with cracked concrete, a layer of the UCF 120 fabric was placed on the top horizontal face of the pier cap, along both sides of the girder pedestals as well as in between the pedestals, parallel to the pier cap's longitudinal direction. The uniaxial UCF 055 CFRP fabric has a tensile capacity of 245 kN per 305 mm (55 kips per 1-ft) width of fabric. It was placed in continuous horizontal strips around the perimeter of the pier cap. To anchor the retrofit, a layer of the braided triaxial TCF 012 CFRP fabric was wrapped perpendicular to the previous two layers within the spaces along the pier cap between the pedestals. The triaxial fabric is a quasi-isotropic CFRP fabric with braided fibers running in 0°, and ±60° directions. The primary advantage of this fabric is that it provides approximately the same tensile capacity along any direction in the plane of the fabric. The triaxial CFRP fabric used in the present design has a tensile capacity of 53 kN per 305 mm (12 kips per 1-ft) width of fabric in all directions.
